VANZETTI SYSTEMS INC. STOUGHTON MA
INFRARED DETECTION OF FAULTY SOLDER JOINTS. PHASE 2-2.(U)
MAR 82 A C TRAUB

Infrared Detection of Faulty Solder Joints

Phase 2.2

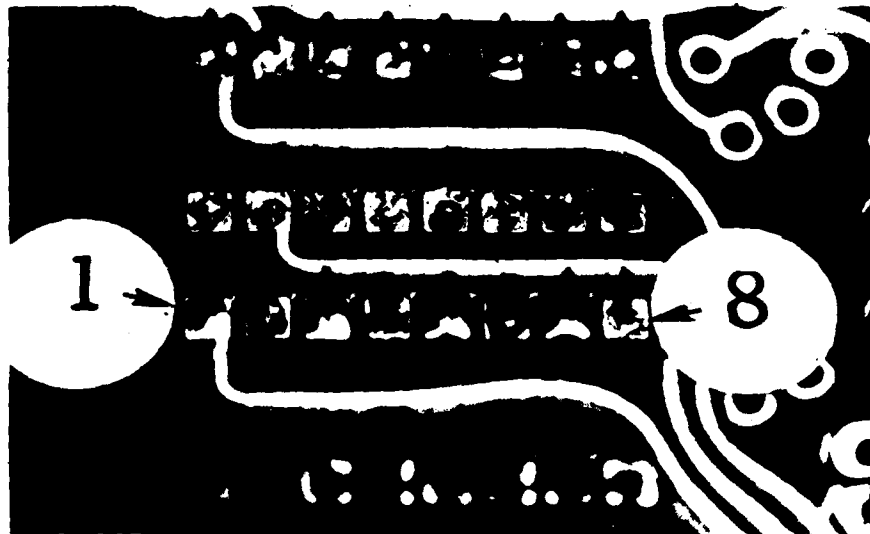
Figure 9. Alternating sequence of "good" and "cold solder" joints from No. 1 through No. 8.

The first coating to be tested was the silicone resin. This was applied to a section of sample board which contained a row of eight through-hole joints which alternated between good and bad. The "bad" ones comprised cold solder joints. The eight samples can be seen in Figure 9 where the alternating qualities of successive joints are easily seen, with the odd-numbered ones being shiny and the even ones dull.

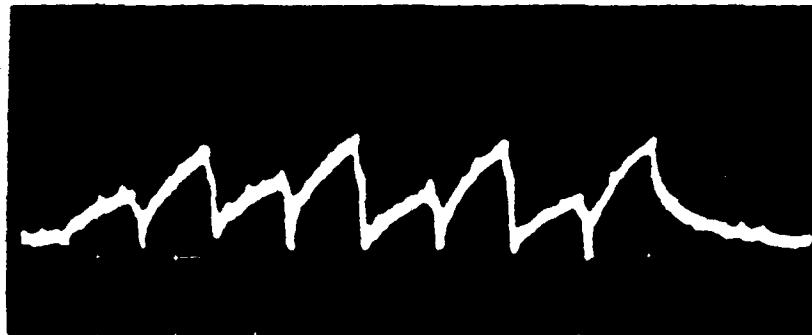
Figure 10. Thermal signatures of uncoated joints.

Figure 10 is a set of thermal signatures of these joints in their uncoated state. On the same vertical scale, Figure 11 shows the signatures after the joints had received an approximately 0.005"-thick coating of the resin.
